SPRING STREET ELEMENTARY SCHOOL

Spring Street Shrewsbury, MA 01545

PROJECT: TOWN OF SHREWSBURY ACCESSIBILITY PROJECT SPRING STREET ELEMENTARY SCHOOL BRAWING: FLOOR PLAN SCALE: 1/32" = 1'-0"
DATE: FEBRUARY 2002

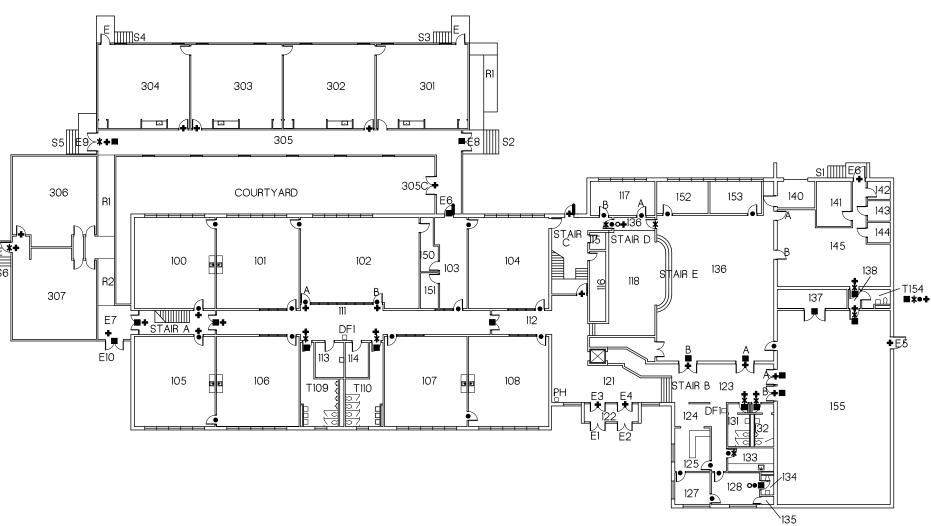
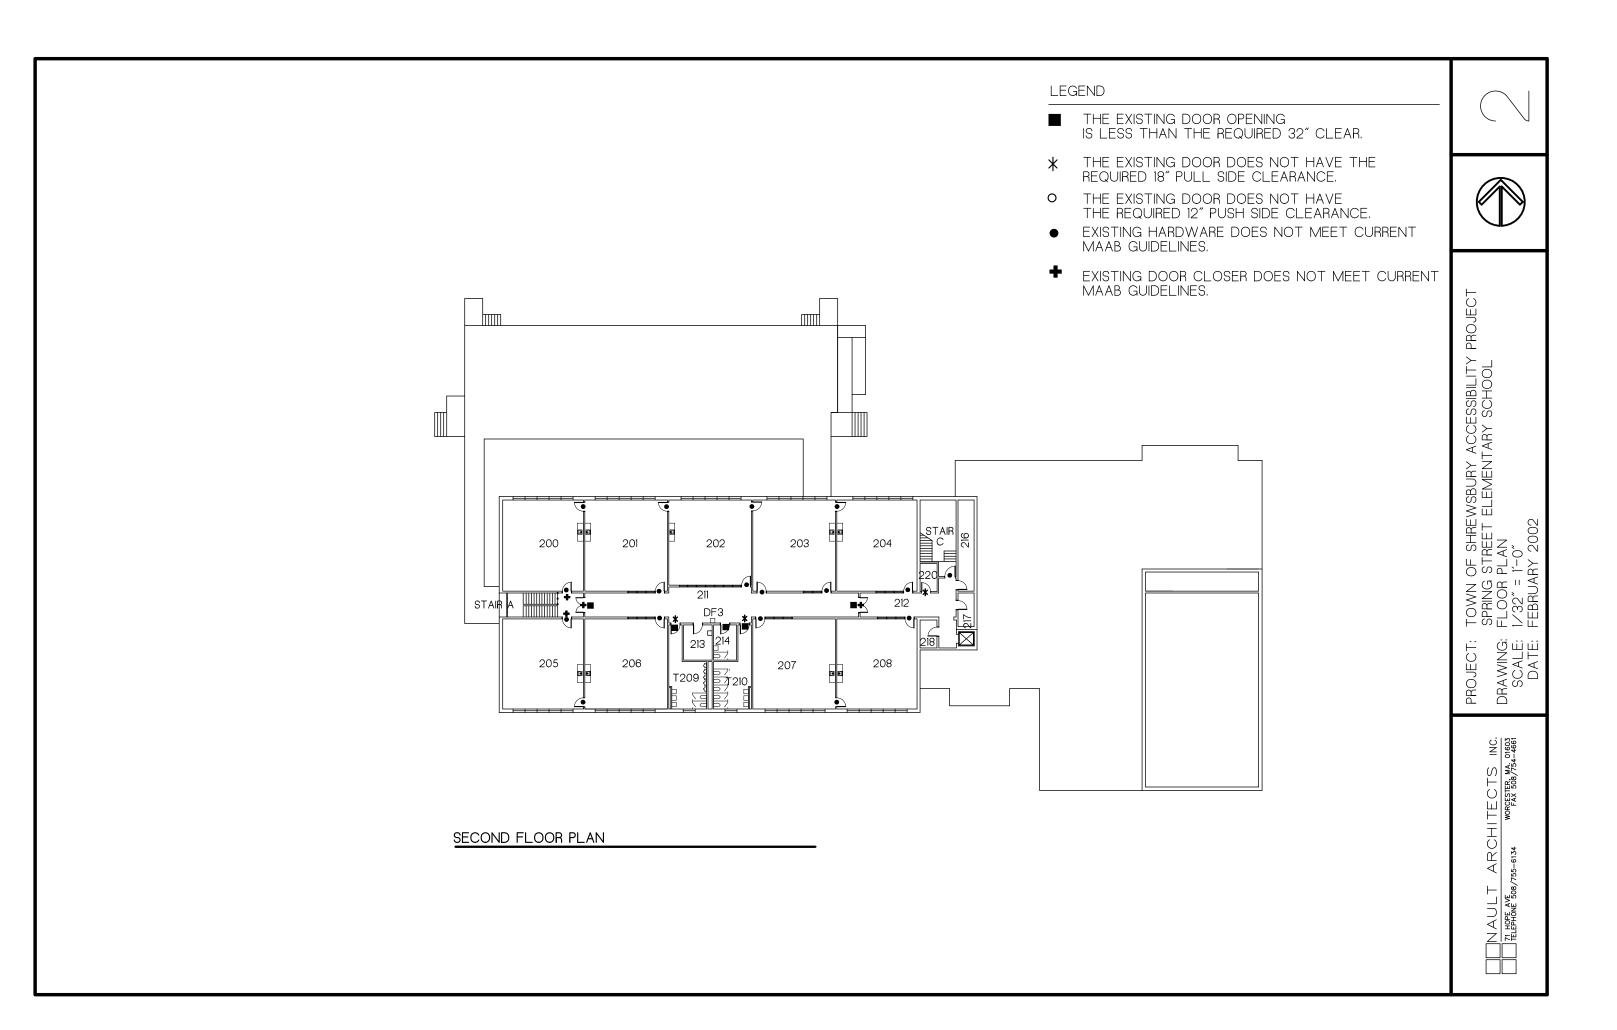
FIRST FLOOR PLAN

- THE EXISTING DOOR OPENING IS LESS THAN THE REQUIRED 32" CLEAR.
- THE EXISTING DOOR DOES NOT HAVE THE REQUIRED 18" PULL SIDE CLEARANCE.
- O THE EXISTING DOOR DOES NOT HAVE THE REQUIRED 12" PUSH SIDE CLEARANCE.
- EXISTING HARDWARE DOES NOT MEET CURRENT MAAB GUIDELINES.
- * EXISTING DOOR CLOSER DOES NOT MEET CURRENT MAAB GUIDELINES.
